Date: 03/10/11
To: Minerals File UTU-68061
From: Ted McDougall, Geologist
Subject: Surface Management Site Inspection, Denison Mines, Rim/Columbus Mine, UTU-68061 (M037/006), West Summit, San Juan County, Utah.

Date of Inspection: 03/09/11
Time of Inspection: 11:00 A.M.
Participants: Ted McDougall
Legal Description: T. 31 S., R. 25 E., Section 29 and 30
Mining Claims Involved: Humbug, Poor Boy, and Columbus Groups
Claimant/Operator: Denison Mines Corp.

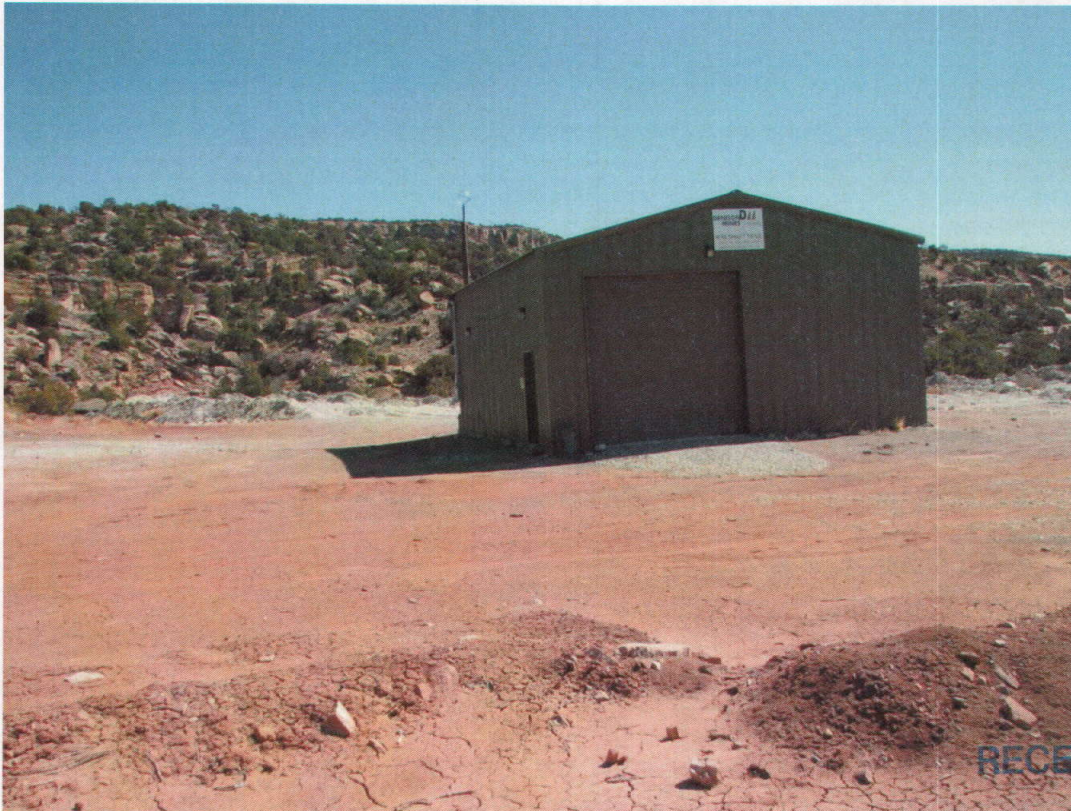
Humbug Portal/Shop Area

The gate at the portal is secure and the work areas around the Rim Shaft and Humbug Portal/Shop area have been cleaned up.

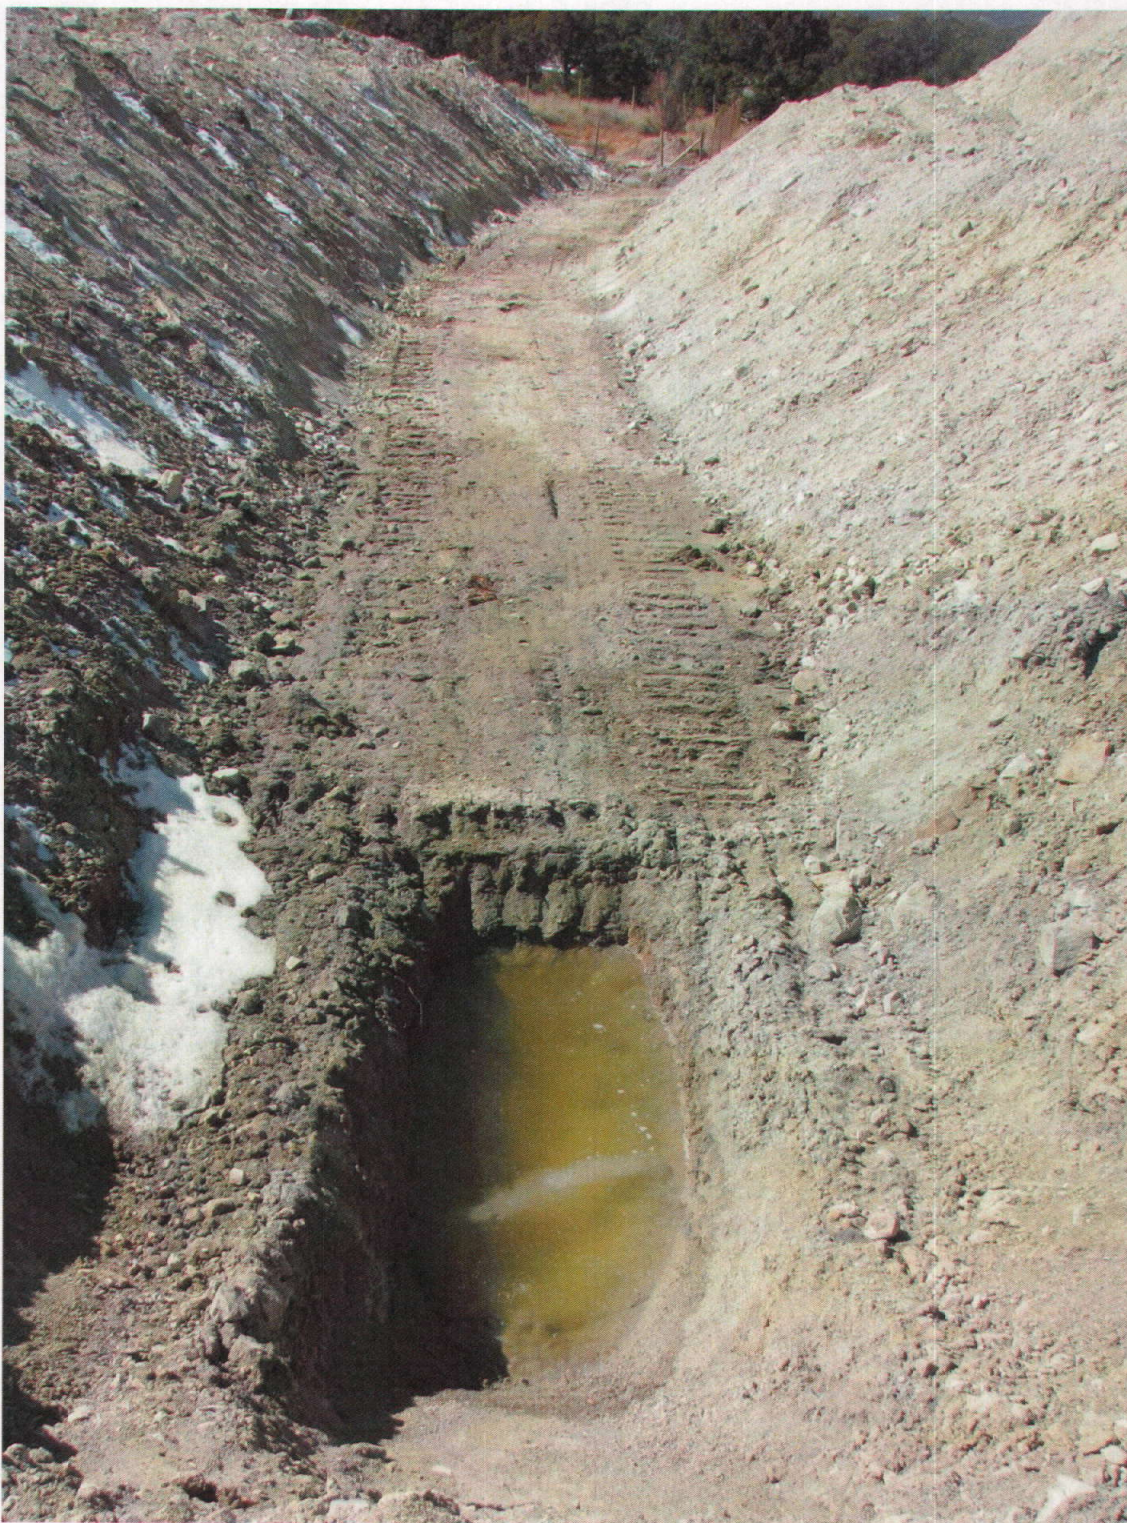
The operator has opened up a large channel in the waste rock pile in an effort to identify the source of a small seep at the base of the dump. The channel extends from the area of the seep to a point approximately 100-150 feet to the east. A small sump has been excavated at the bottom of the channel at its east end. The sump is currently full of water but it is difficult to determine if water is result of snowmelt or subsurface flow. The operator will likely have to wait until summer before an evaluation can be done.

Channel excavated through waste rock pile with small sump at east end.
